# **INVESTIGATION OF WATER LEAKAGE MECHANISM IN THE KARSTIC DAM SITE, SAMANALAWEWA, SRI LANKA**

A Dissertation submitted in partial fulfilment of  
the requirements for the  
Degree of Doctor of Philosophy

Department of Engineering Systems and Technology  
Graduate School of Science and Engineering  
Saga University  
Saga, Japan

**September 2007**

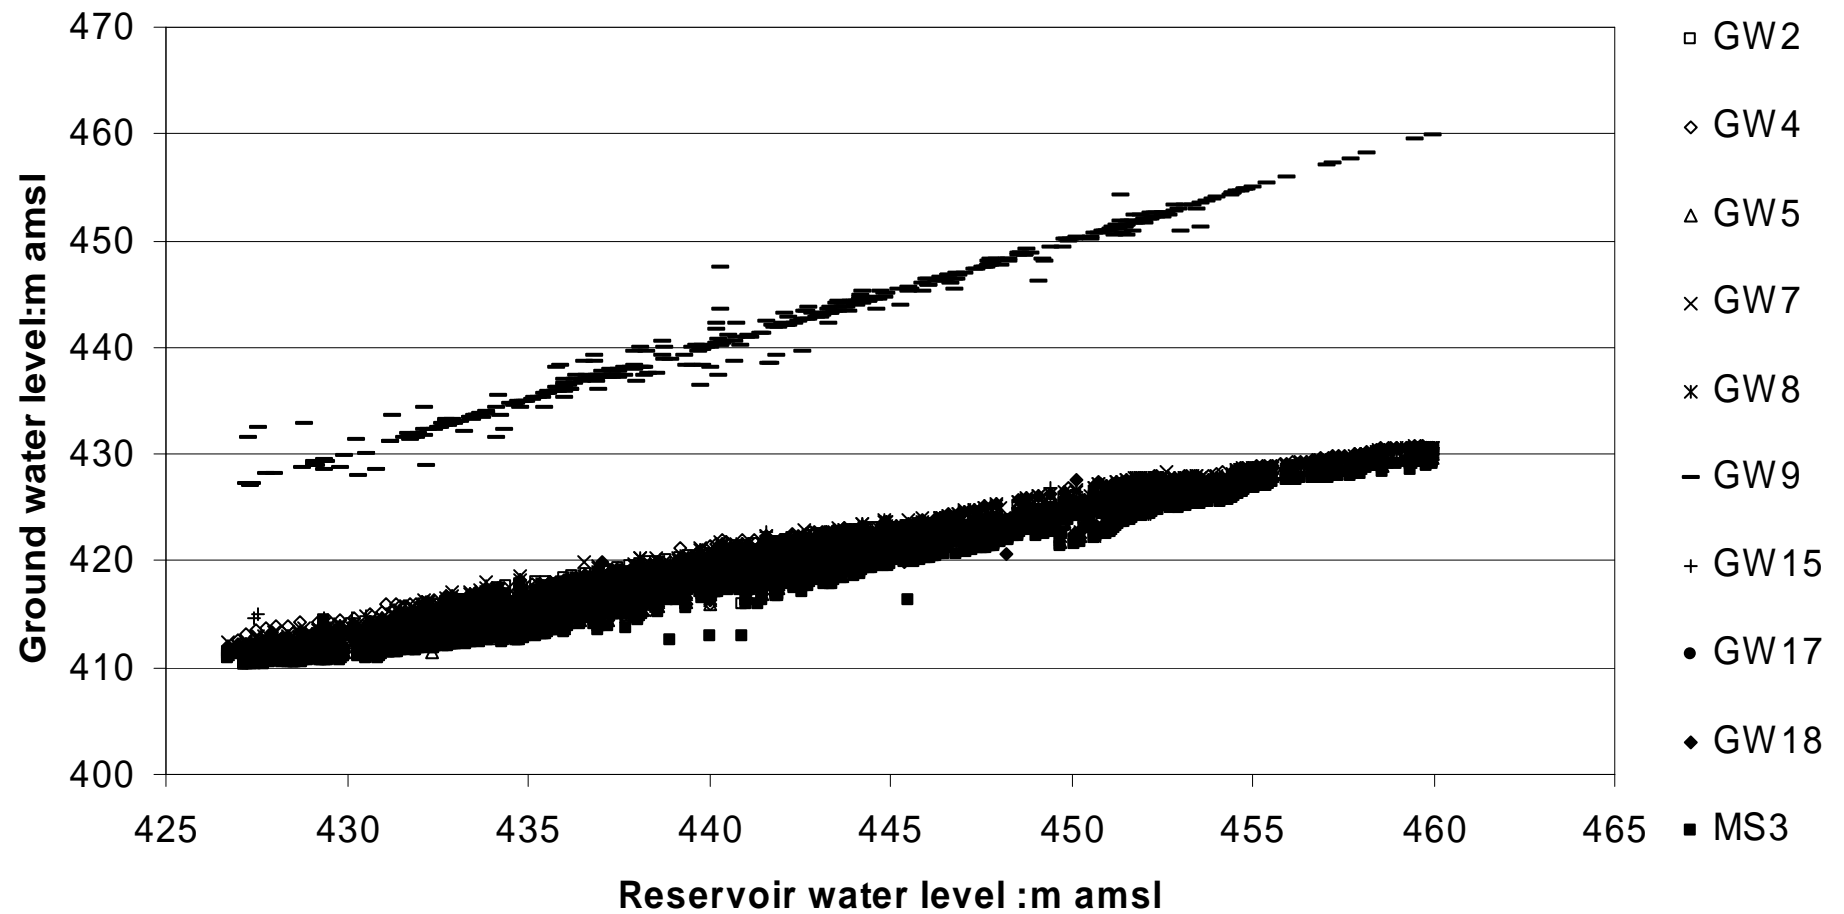
Similarly, when the behaviour of the right bank during 1999 to 2005, i.e. after the earth blanket construction is considered, an equal correlation between the ground water level and the reservoir water level can be observed with an average slope of 0.62.

As observed in the above graphs even after a 10m drop in the ground water level as a result of earth blanket construction, the right bank ground water behaviour shows a linear variation against reservoir water level changes.

**Figure 5.5** Ground water level against reservoir water level of GW and MS series observation wells during 1999 - 2005

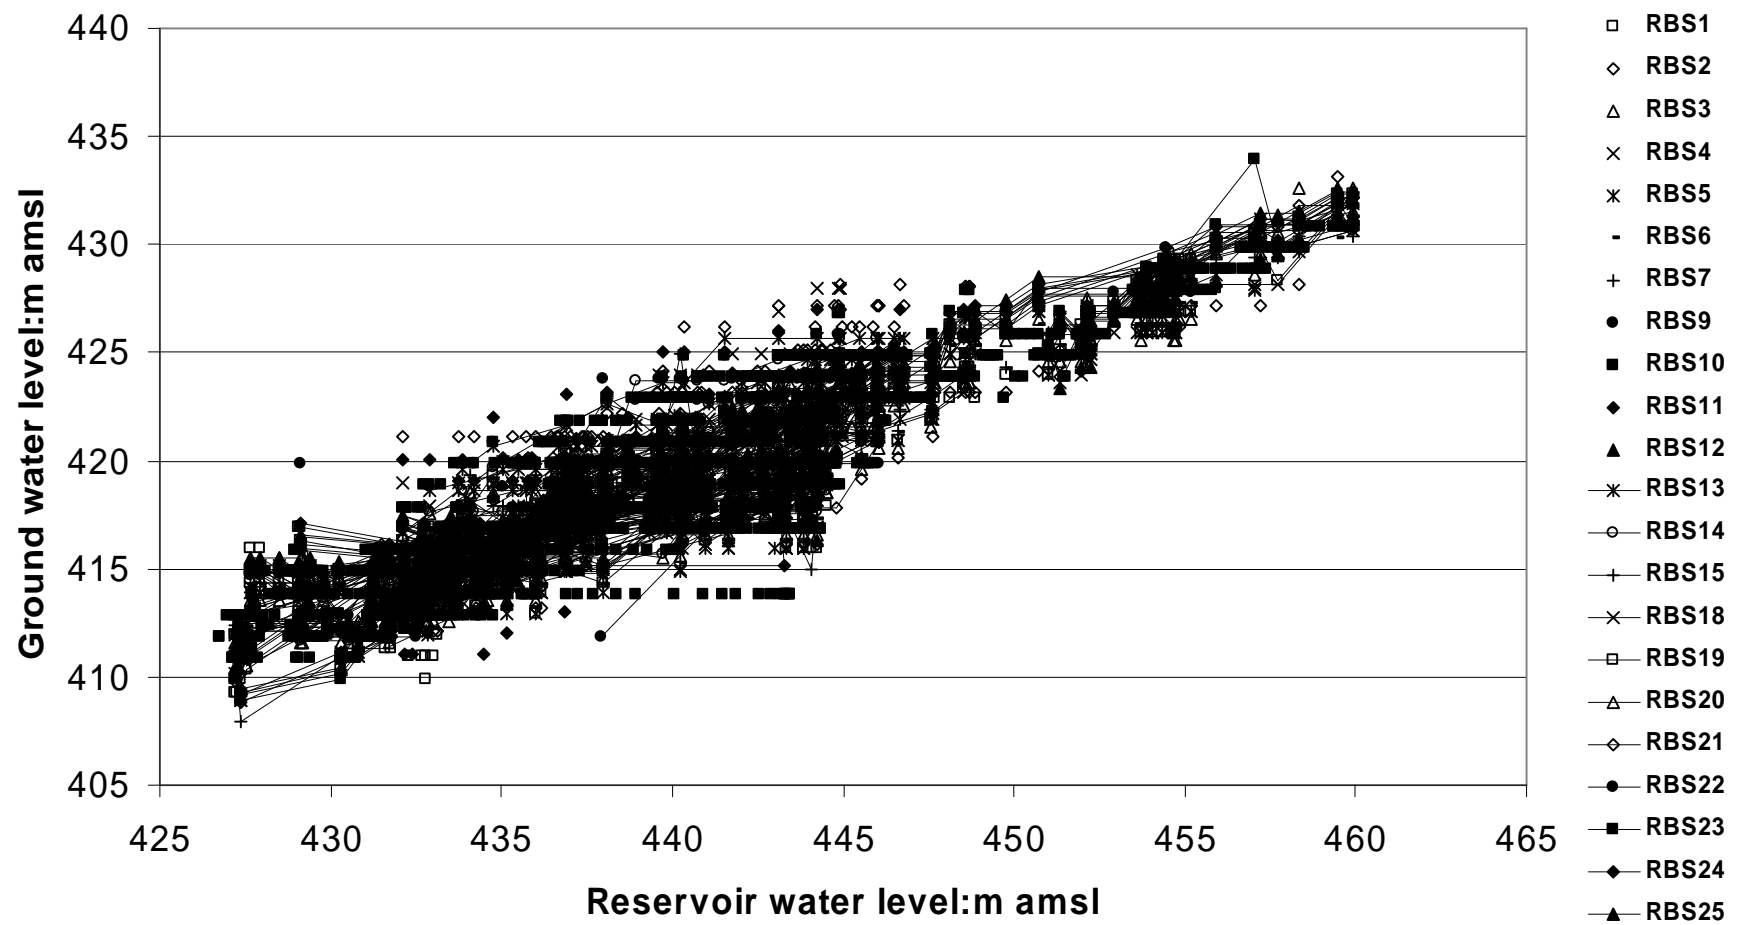
**Figure 5.6** Ground water level against reservoir water level of RBS series piezometers during 1999 - 2005

However the slope of the line has dropped giving average values of 0.62 for GW and SP series observation wells and 0.61 for the RBS and SP type standpipe piezometers. The slope values derived for each bore hole and standpipe piezometer are given in the Table 5.4 ,GW and SP series observation wells and Table 5.5 RBS and SP type standpipe piezometers. They are also presented in graphical format in the Figure 5.4 in combination with the previous results.

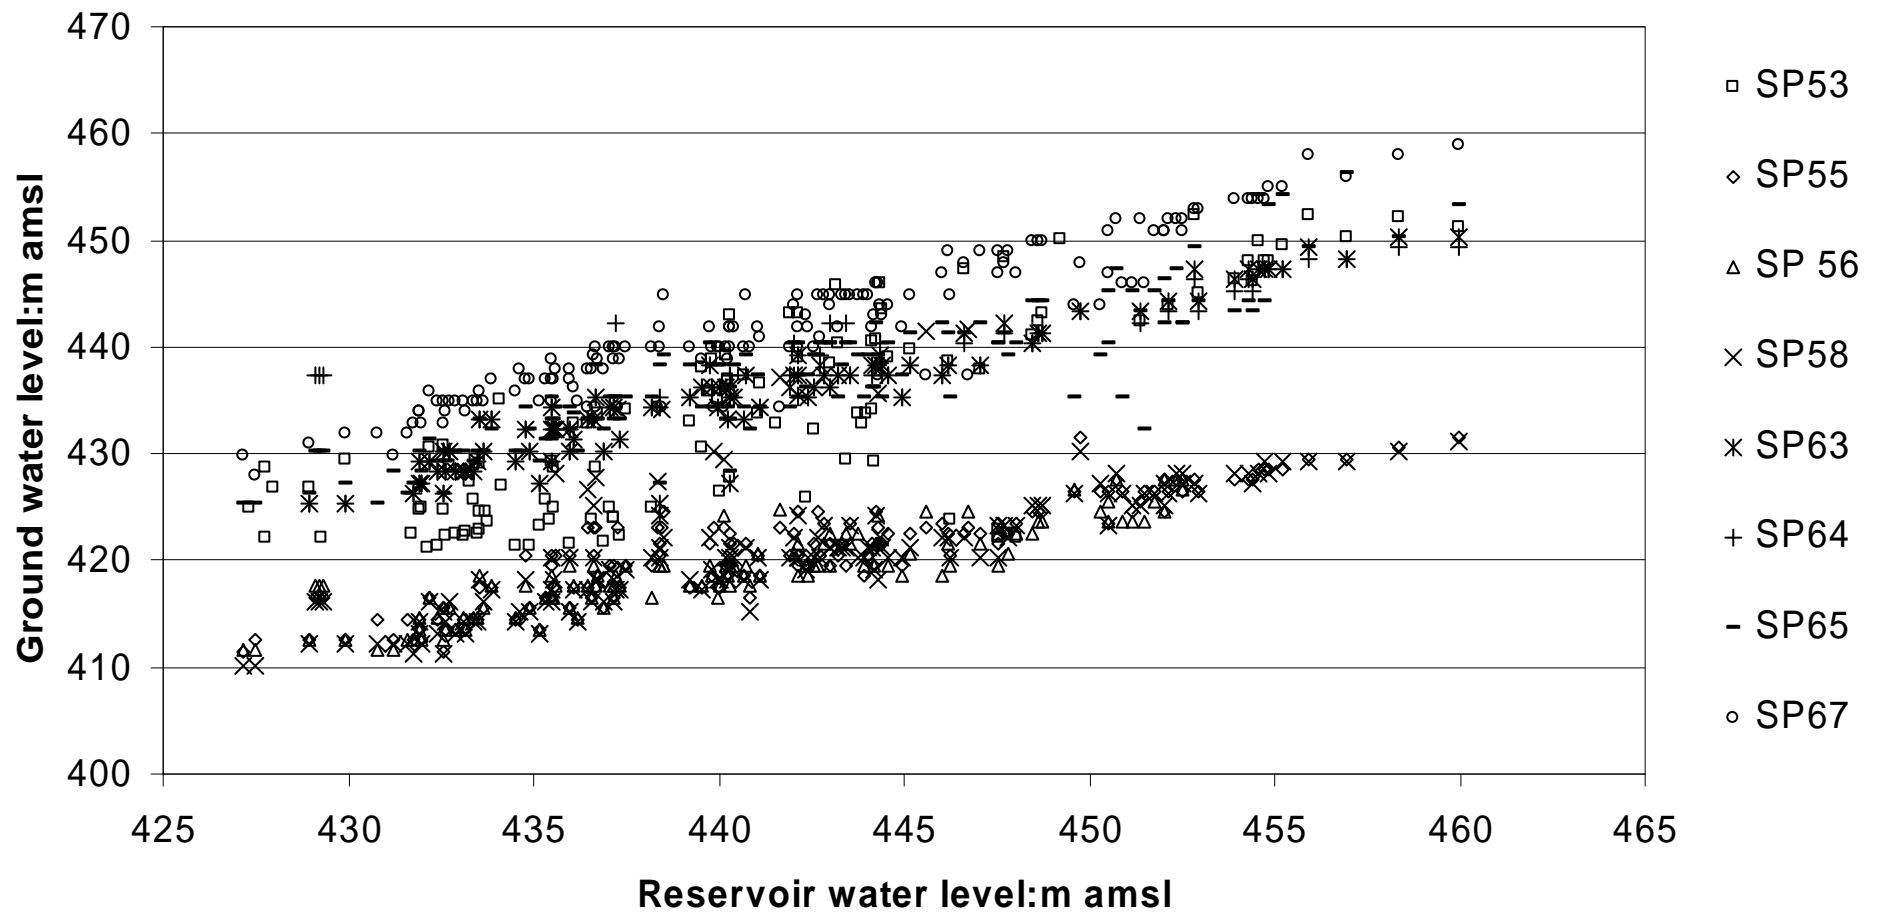
**Figure 5.7** Ground water level against reservoir water level of SP series piezometers during 1999 – 2005

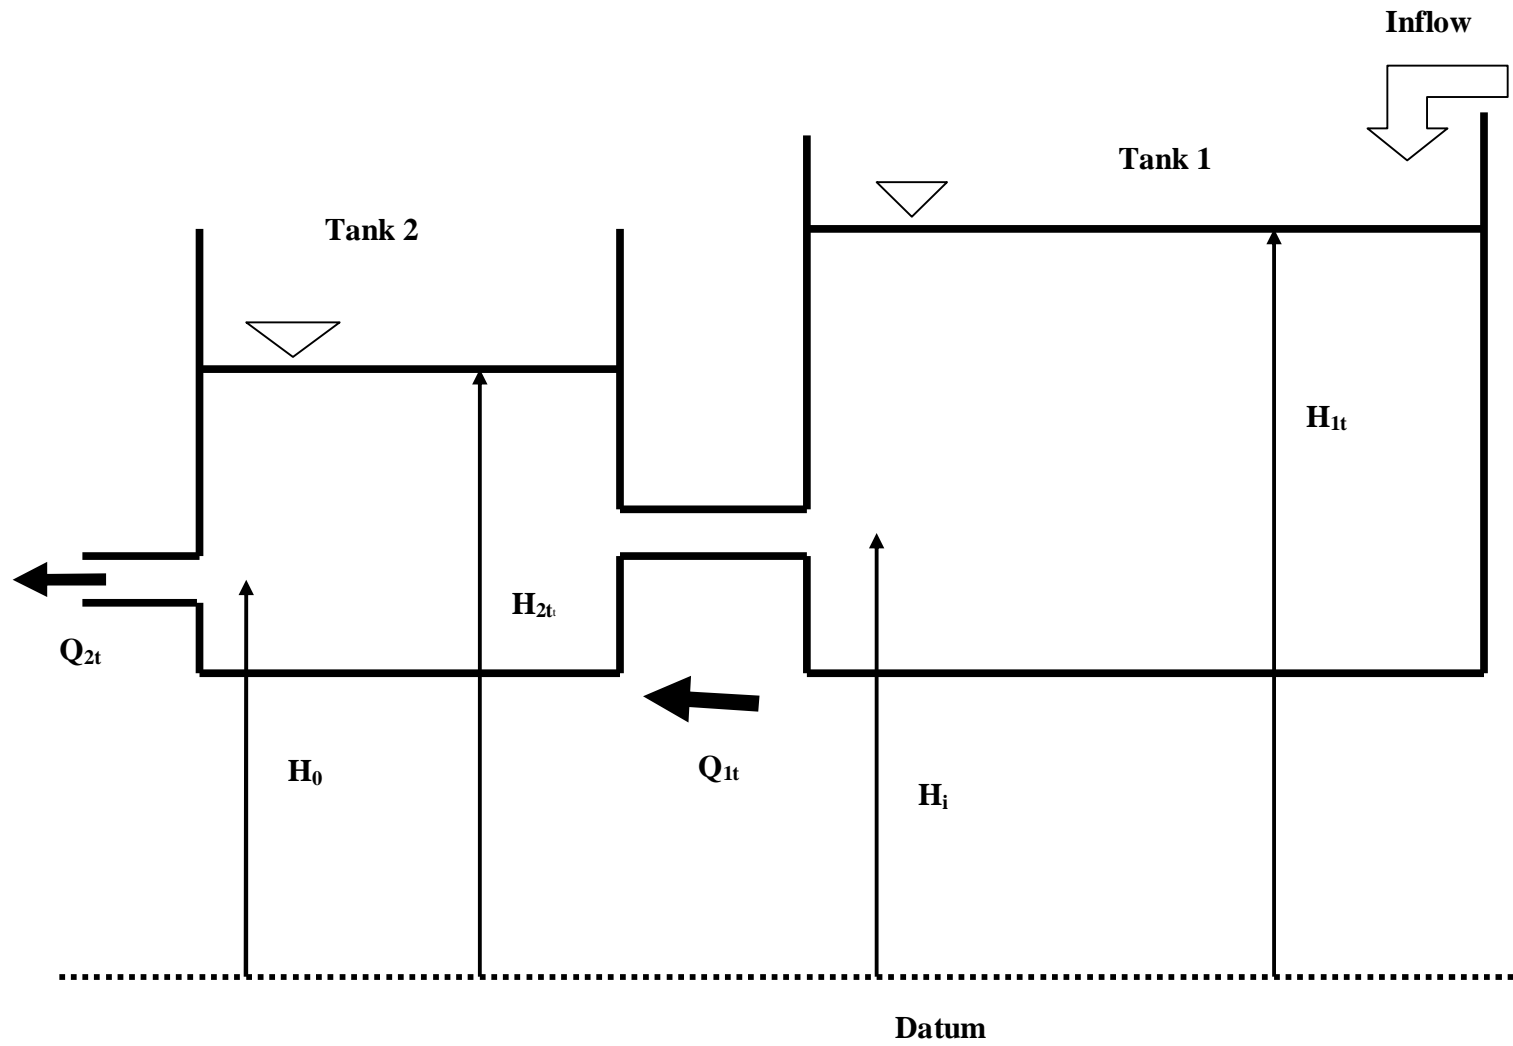
As an attempt in understanding the above characteristics observed in the ground water level data analysis let's consider a simple two interconnected tank system. The Figure 5.8 shows the schematic view of the considered tank model.

**Figure 5.8** Lay out of the two tank model

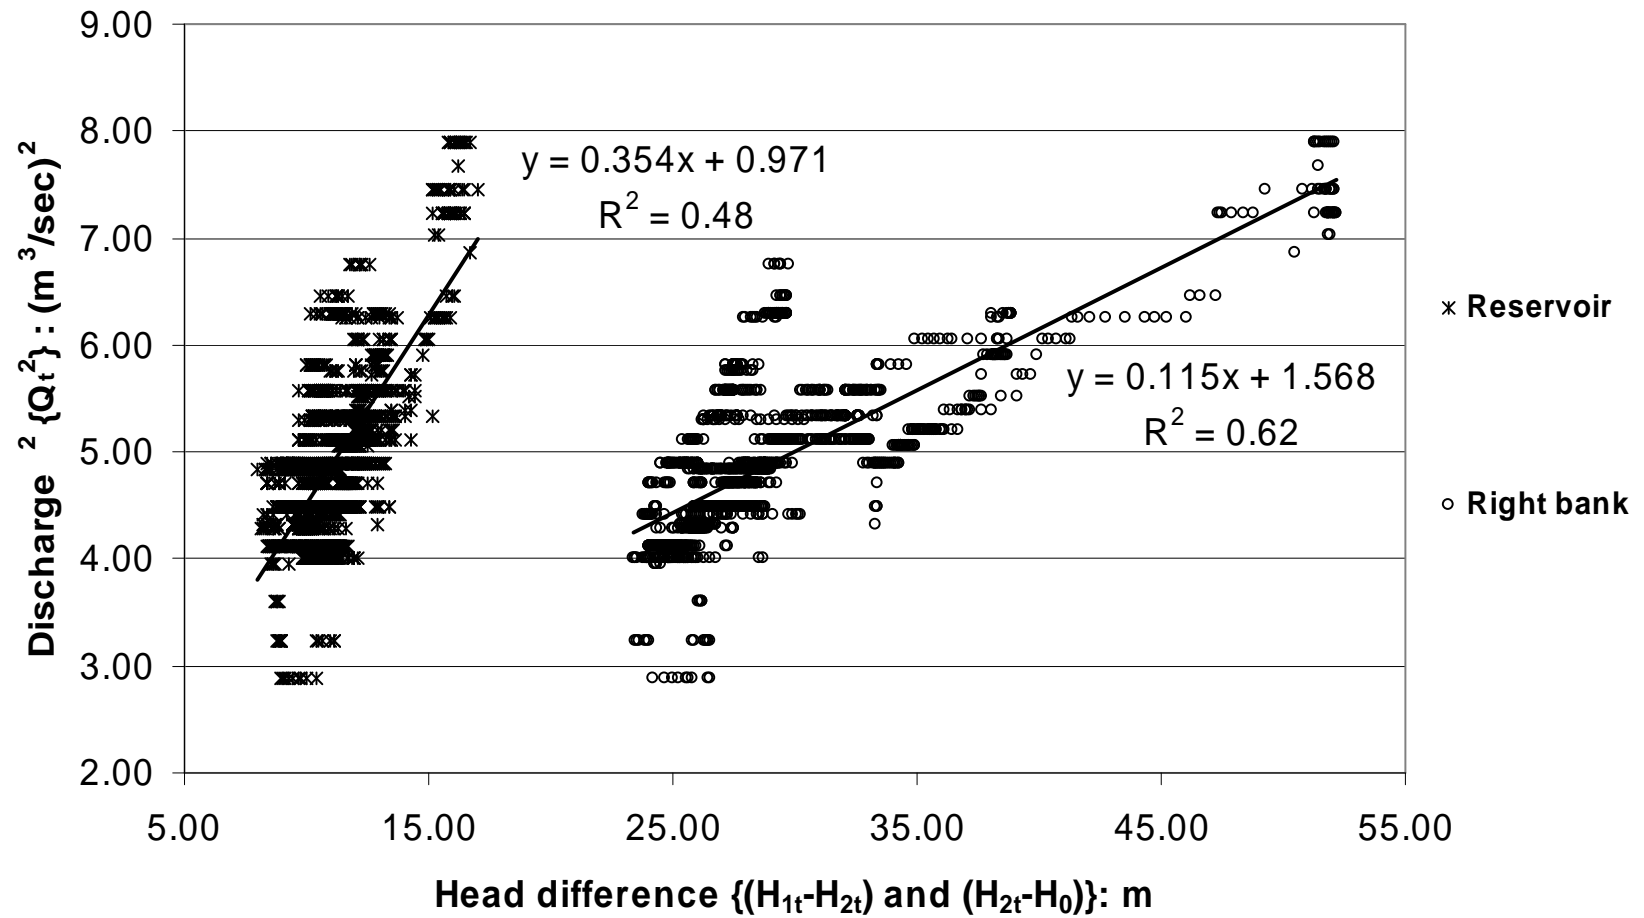
$K_1^2 = 0.354$  during 1993 -1997 (from Figure 5.9) and  $= 0.175$  during 1999-2005 (from Figure 5.10)

**Figure 5.9** Square of discharge against the head difference for the period 1993 - 1997

$K^2_2 = 0.115$  during 1993 -1997 (from Figure 5.9) and  $= 0.122$  during 1999-2005 (from Figure 5.10)

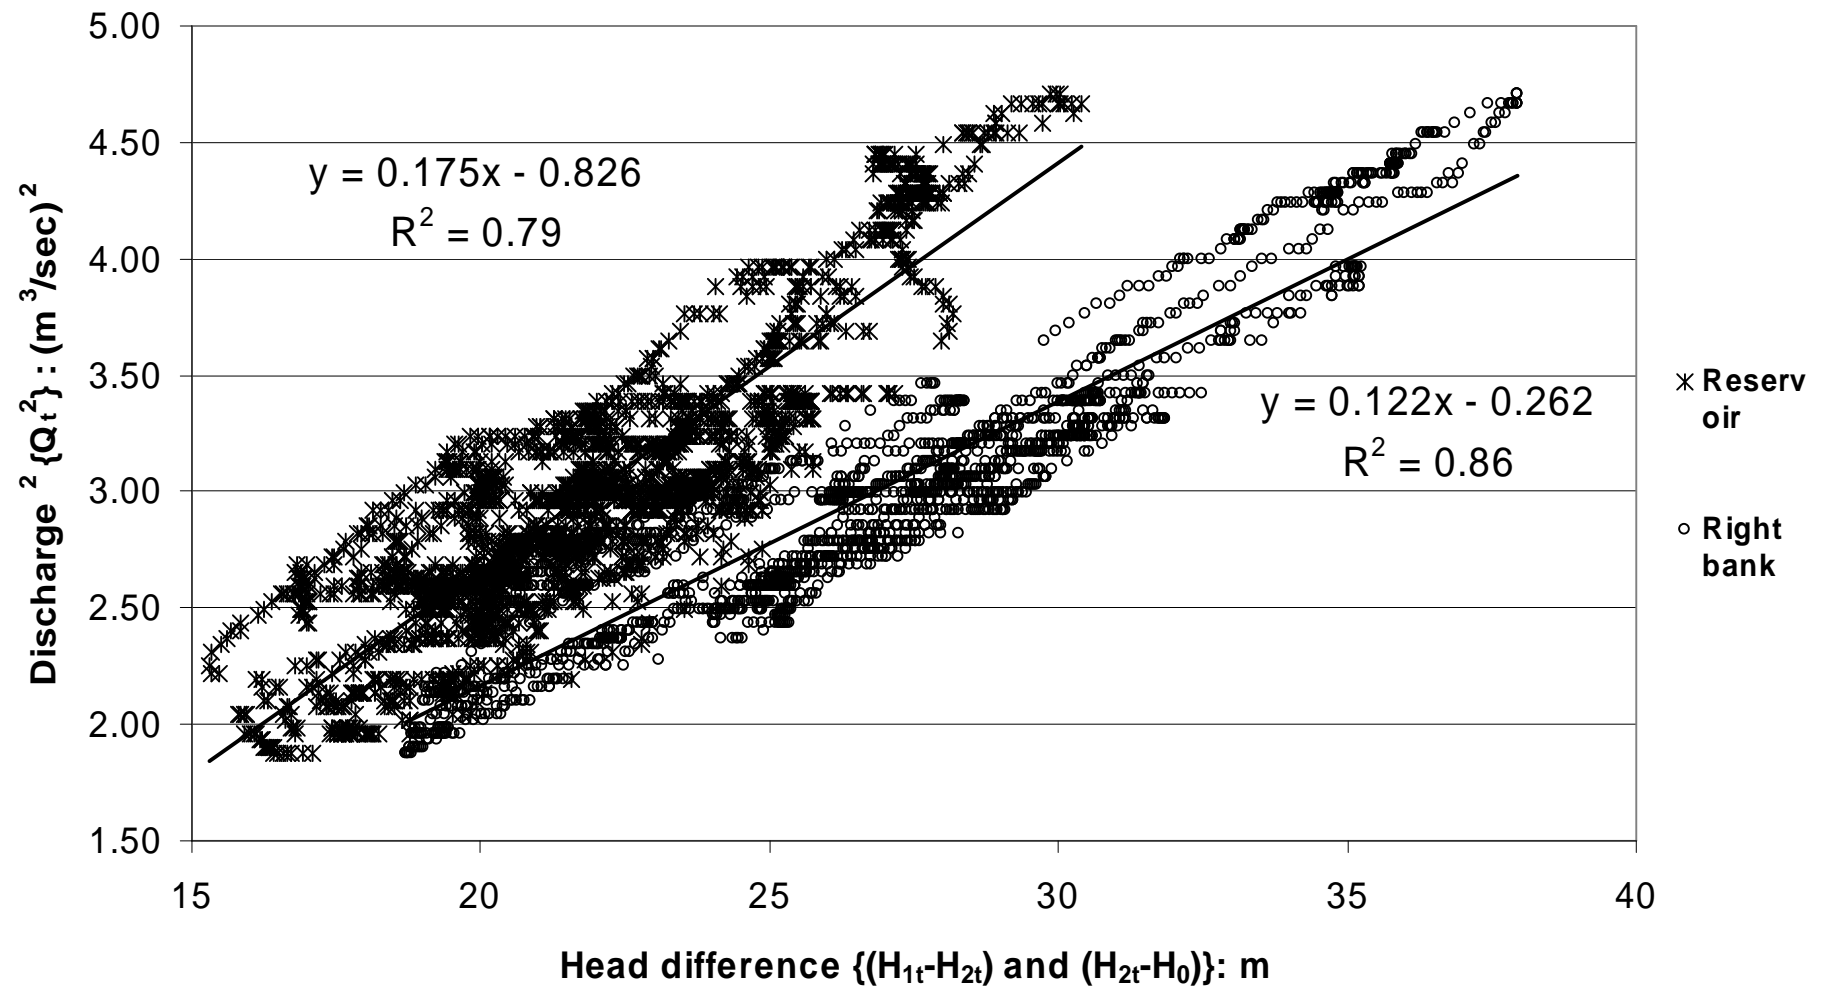
**Figure 5.10** Square of discharge against the head difference for the period 1999 - 2005

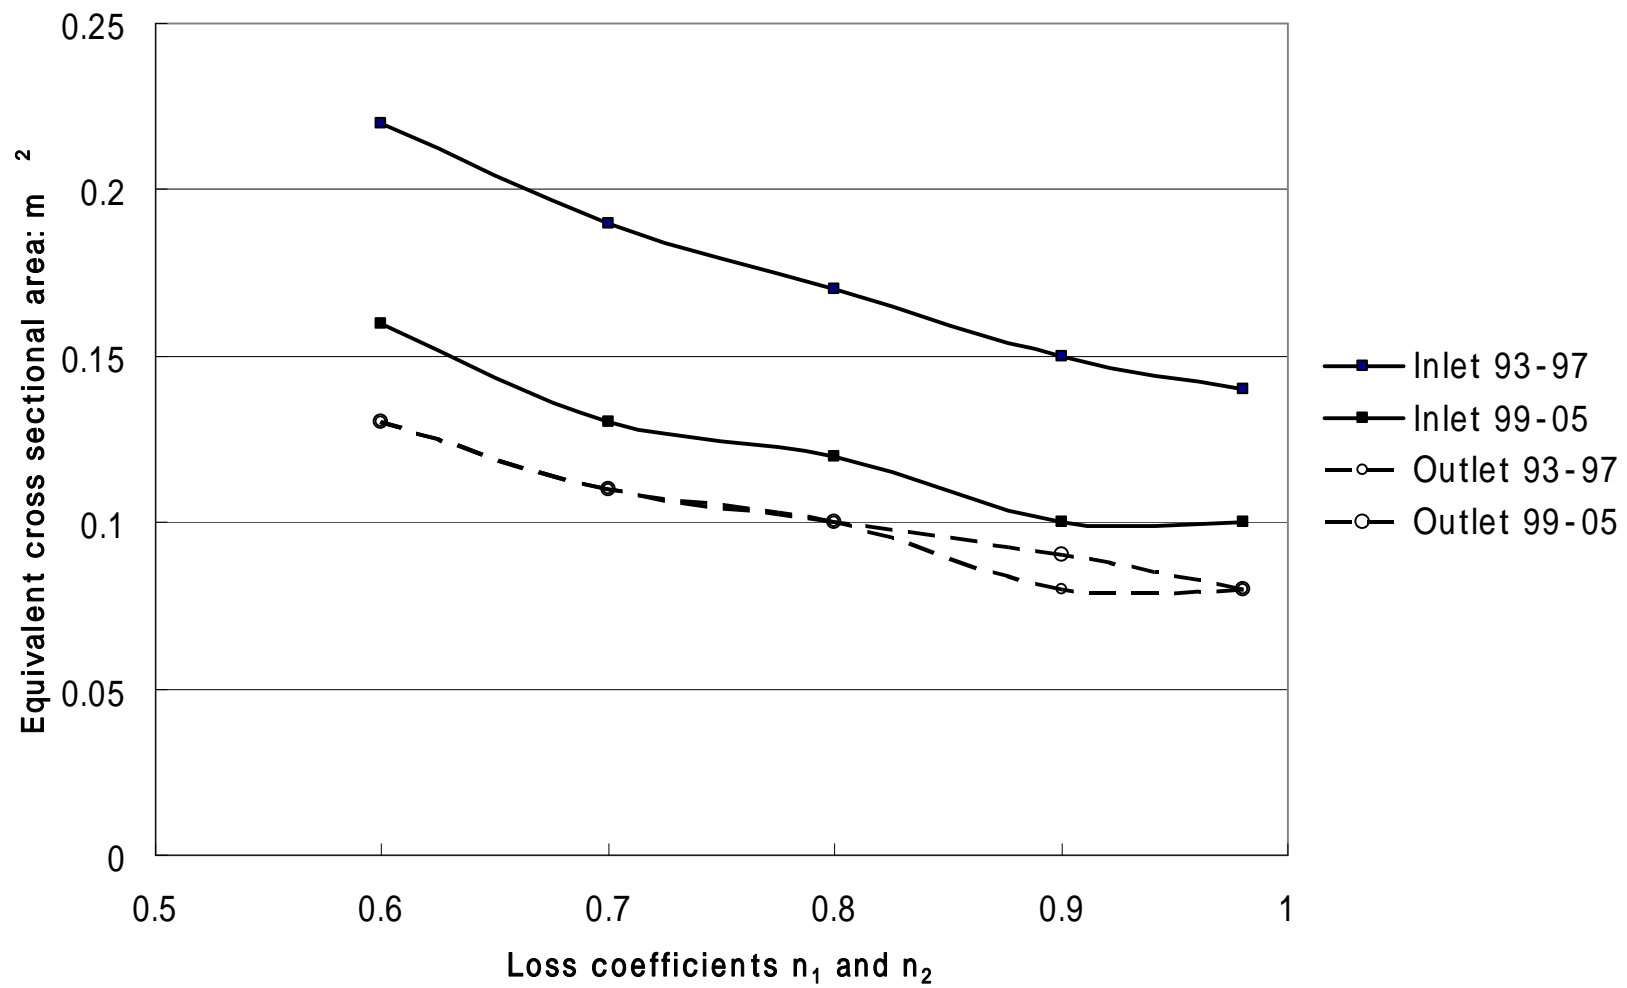
However it has been shown that for this type of two tank systems the loss coefficient values in the range of 0.98 to 0.60 are applicable. Therefore the values of  $a_1$  and  $a_2$  are calculated for the above range of  $n_1$  and  $n_2$  values as given in Table 5.6 below. The Figure 5.11 shows the graphical presentation of the calculated  $a_1$  and  $a_2$  (equivalent cross sectional areas) values.

According to the above table, the equivalent cross sectional areas of the inlet and outlet are found to be of the same order.

Further the derived equivalent cross sectional area of the out let tallies with the actual cross sectional area of the main leakage outlet, which is found to be in the range of 0.10 to 0.20 m<sup>2</sup>.

Therefore based on the above results it can be deduced that the equivalent cross sectional area of the leakage inlets in the reservoir are also in the order of 0.12 to 0.15 m<sup>2</sup>.

**Figure 5.11** Graphical representation of equivalent cross sectional areas

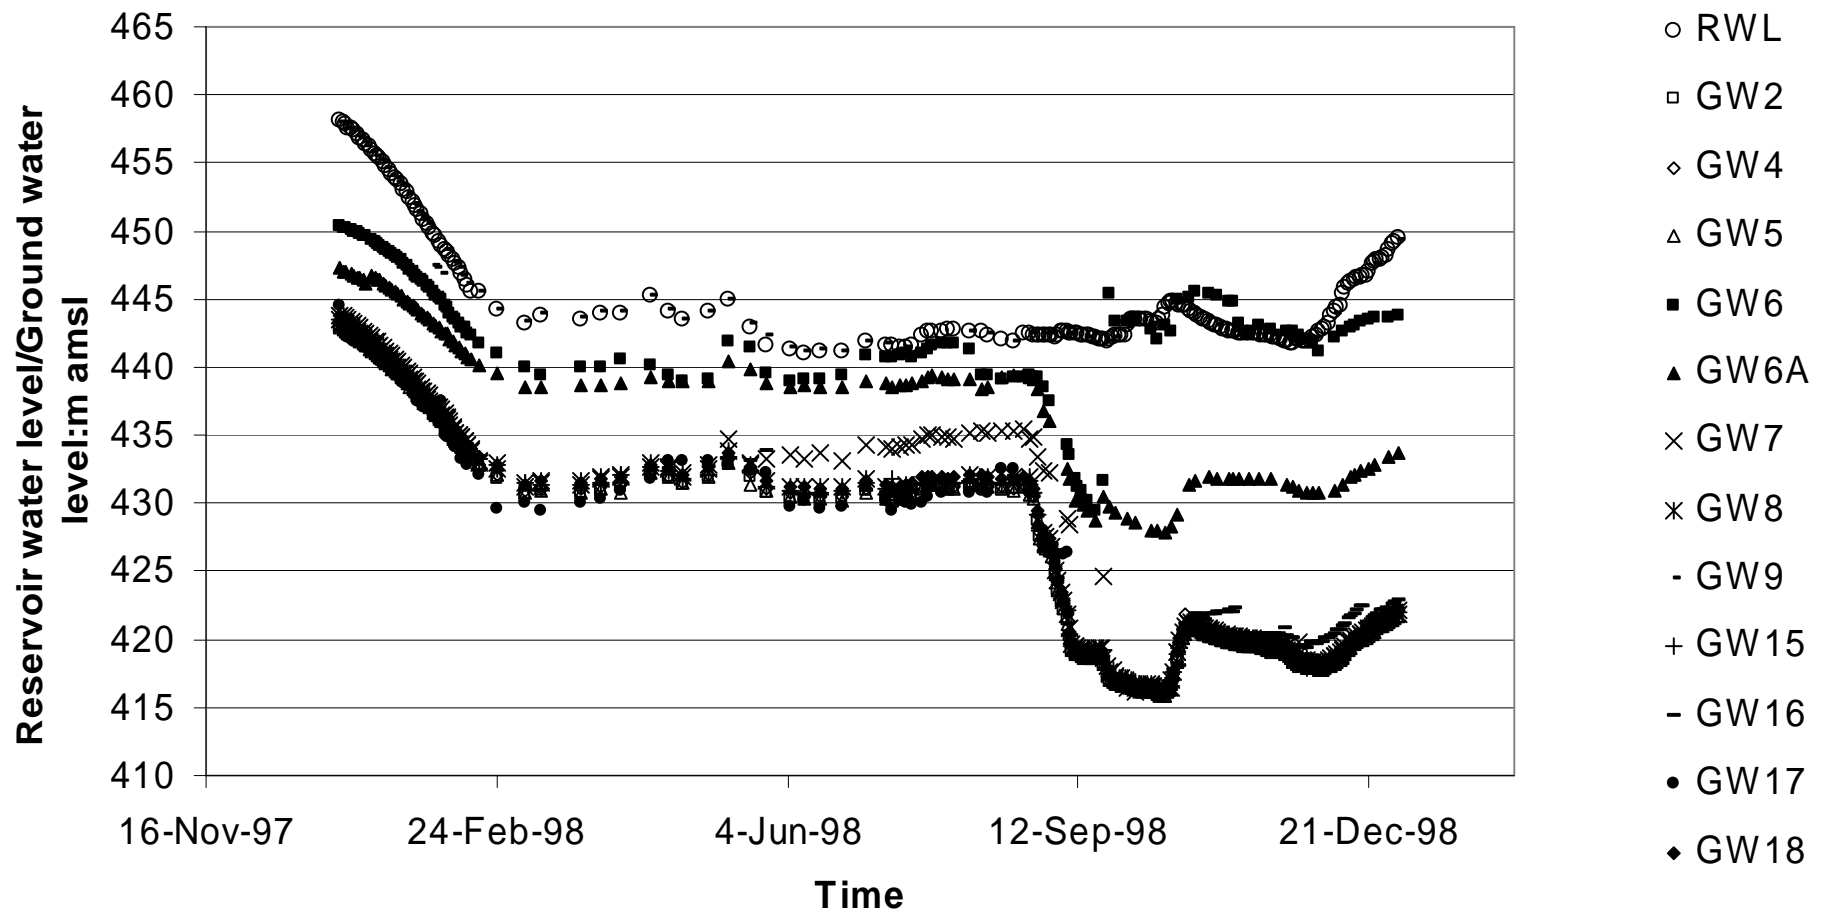
However those above mentioned GW 9 observation well and the five piezometers do not show any response and continue to follow the reservoir water level during the both events. In other words they are found to be intact by the two events which caused the whole right bank ground water level to drop abruptly. At the same time the bore hole GW 9 and SP67 piezometer continue to show a ground water level almost similar to the reservoir water level while the other four piezometers showing a level little lower than the reservoir water level through out.

When the piezometric head variation of the observation well GW 9 and above piezometers is compared with the two tank system it is found that it is equivalent to the piezometric heads shown by points lying along the connecting path of the two tanks. Therefore it can be postulated that in the real scenario, the above GW 9 and the above mentioned SP piezometers are lying along a leakage inlet channel to the right bank. Thus it shows a major leakage inlet is located very close to the dam in the dam right abutment lying along the stretch where GW 9, SP 53, SP 63, SP 64, SP 65, and SP 67 are located. The leakage ingress is supposed to take place through this inlet and travels to the common aquifer in the right bank and there it forms an extensive underground reservoir. The leakage is coming out from an outlet, another cavity opening, found in the other side of the underground reservoir as experienced at present.

**Figure 6.1** Ground water level behaviour shown by GW series observation wells during the earth blanket construction

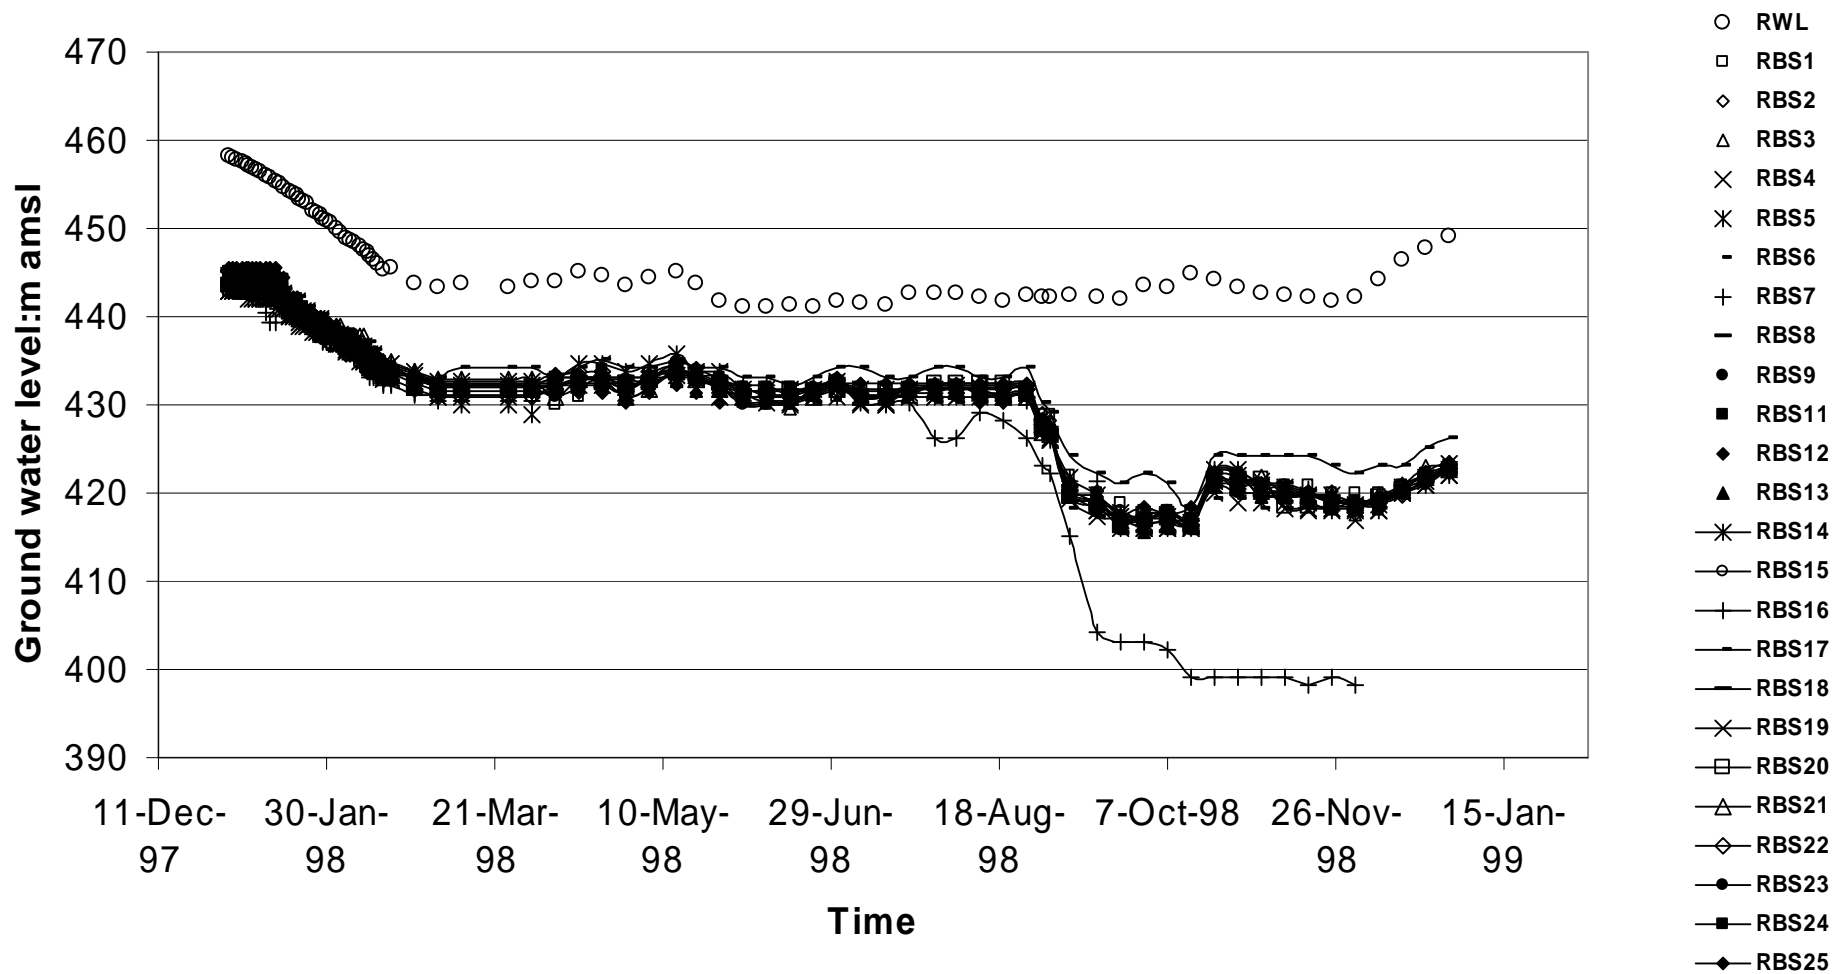
**Figure 6.2** Ground water level behaviour shown by RBS series standpipe piezometers during earth blanket construction

Similarly, earlier sealed cavity in block 'X' area during the earth blanket construction too could have directly fed the right bank aquifer. The behaviour of GW6, RBS 16 and RBS 17 suggest that block 'X' has a direct connection to this area. Immediate response of these observation well piezometers during earth blanket construction confirms it.

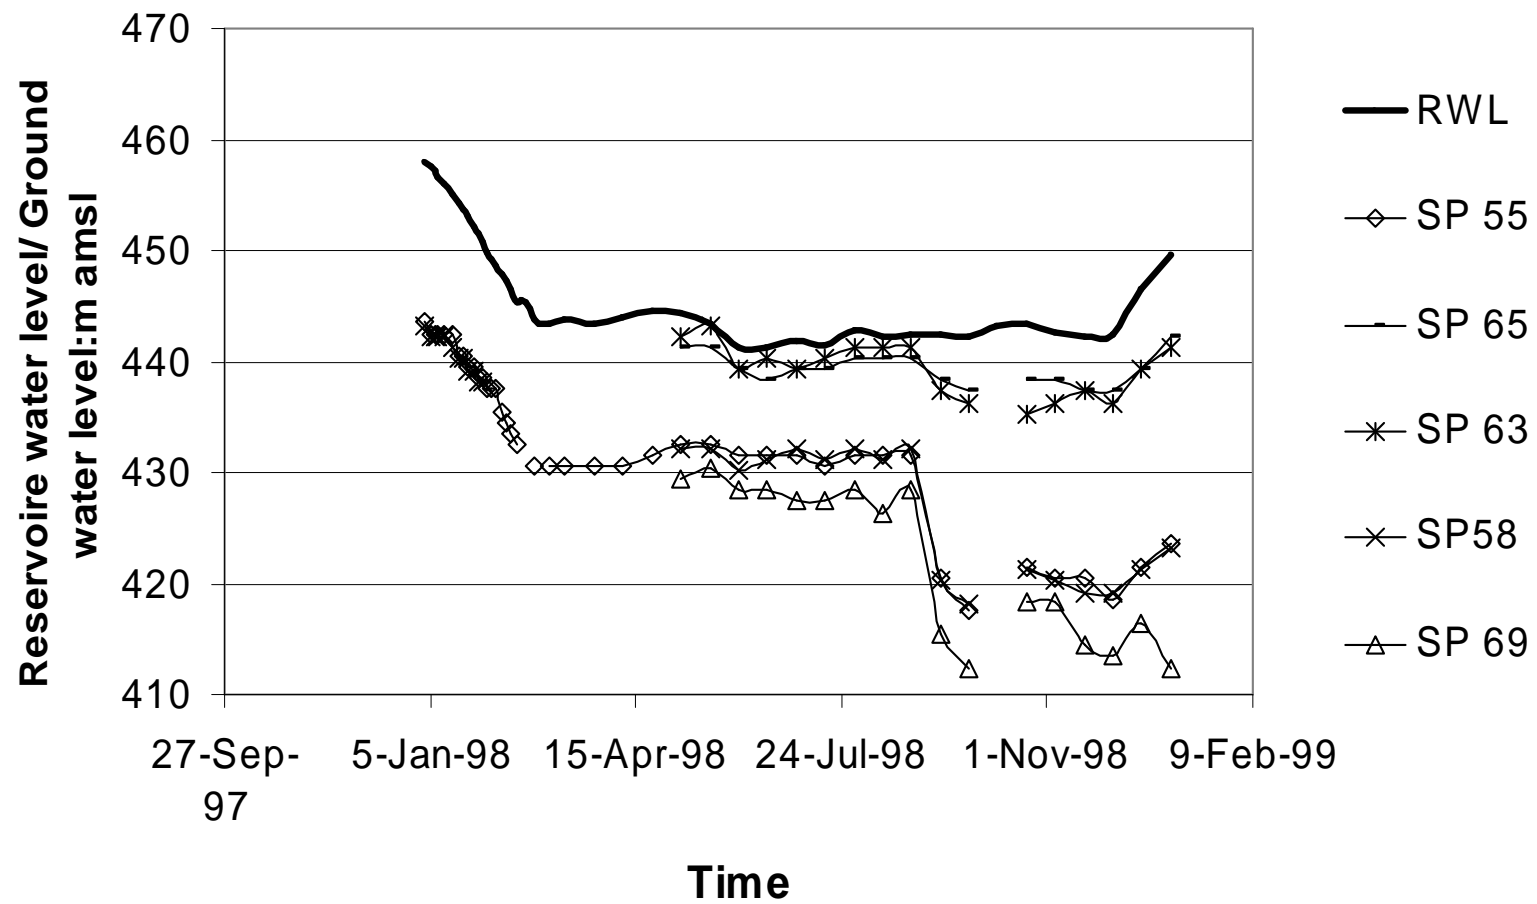
**Figure 6.3** Ground water level behaviour shown by SP series standpipe piezometers during earth blanket construction
